Manhole Inspection Summary

Manhole # S23I__046MH

Insp Date: **6/9/08 10:00 AM**

Location Address: **24 Boyd st**

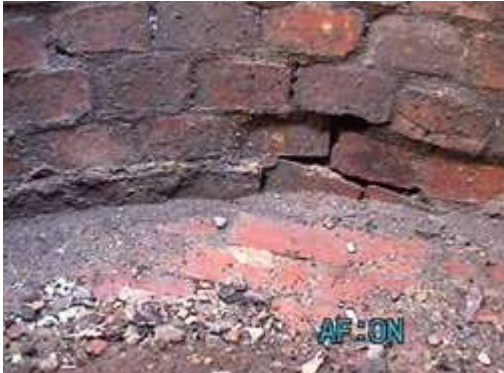
Defect 3

Condition: ☐ Sound ☐ Cracked ☐ Root Intrusion ☒ **Loose Brick** ☒ **Deteriorated**

Infiltration: ☐ None ☐ Joint ☐ Cracks ☒ **Mortar** ☐ Roots ☐ Wall

loose bricks missing mortar barrel bench connect (possible infiltration)

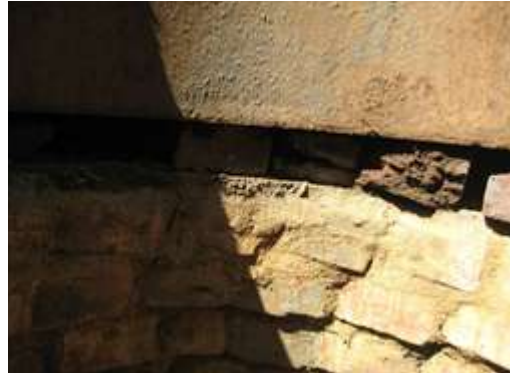
Defect 2

Condition: ☐ Sound ☐ Cracked ☐ Root Intrusion ☐ Loose Brick ☒ **Deteriorated**

deteriated, loose bricks at chimney

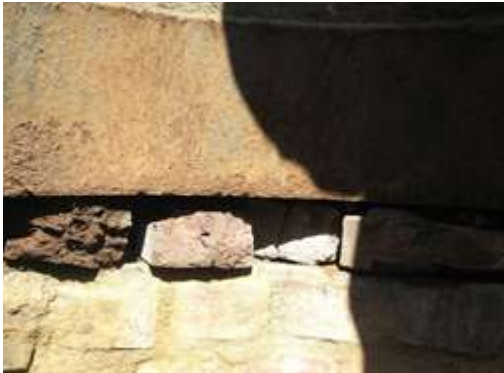
Defect 1

Infiltration: ☐ None ☒ **Joint** ☐ Cracks ☒ **Mortar** ☐ Roots ☐ Wall

missing mortar loose brick chimney-frame joint

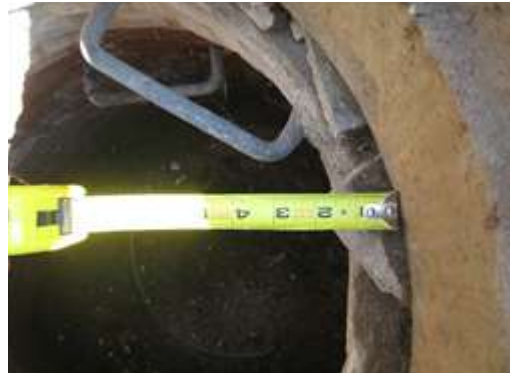
Defect 4

Frame Offset: **1.5** (in.)

1 inch frame offset

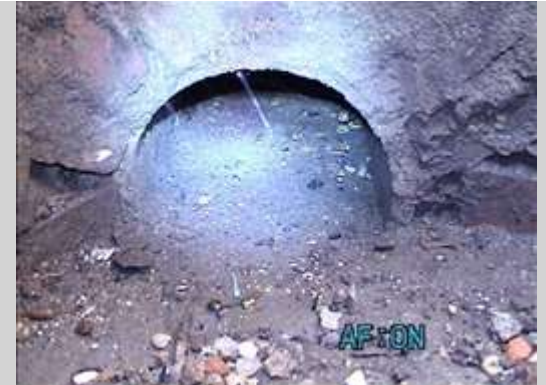
12 O'Clock Outflow

Deposits: ☐ None ☐ Mud ☐ Sludge ☒ **Debris** ☐ Grease

Silt Depth: **2** (in.) Deposits Extent: **Medium**
